# Performance Evaluation of Hinges in Long-Span Cantilever Steel Truss Bridges by Structural Health Monitoring

Takeshi Miyashita,\* Eiji Iwasaki, and Masatsugu Nagai

Nagaoka University of Technology, 1603-1 Kamitomioka, Nagaoka, Niigata 940-2188, Japan

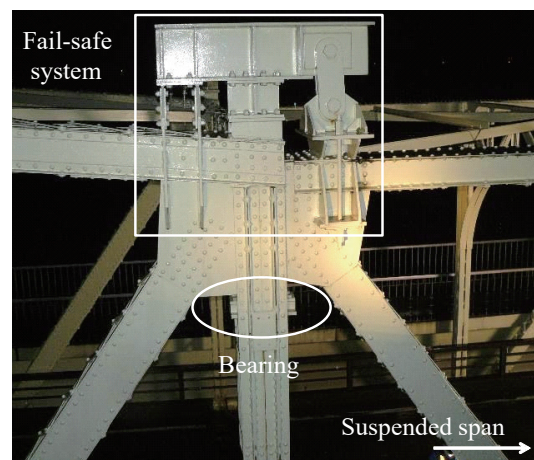
From 1995 to 1996, movable supports and a bridge fail-safe system corresponding to a Gerber hinge section were replaced and installed, respectively. In 2003, construction works to implement nondrain expansion devices in all Gerber hinges were carried out. Figure 2 shows the current condition of the Gerber hinges.

Fig. 2. (Color online) Current condition of Gerber hinges.

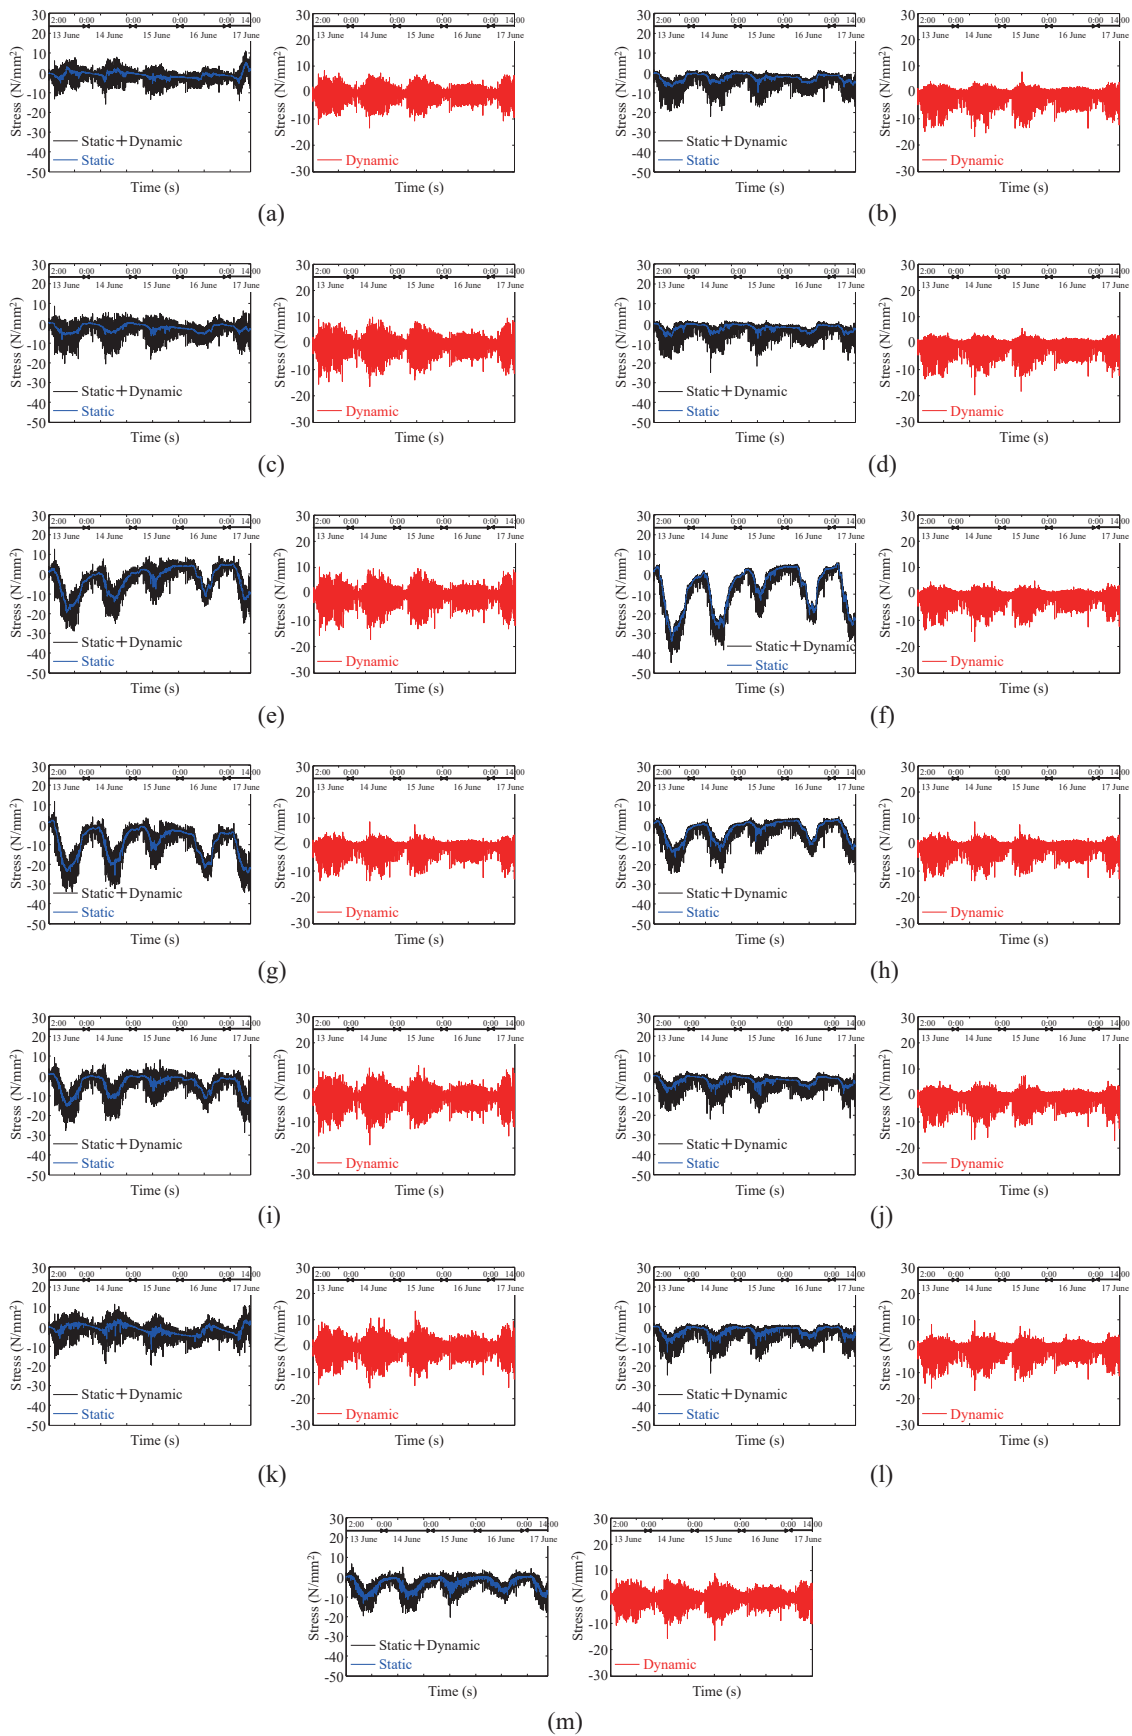
Figure 6 shows the upper chord's normal stress for each span. The black solid line represents the normal stress, which is the sum of the static stress component caused by temperature variation, and the dynamic stress component caused by the live load. To separate the two components, a moving average is carried out. Here, 20000 data items for each time are considered. From this moving average, the static stress component is determined and represented by the blue solid line. Then, the blue solid line's value is subtracted from the black solid line's value in order to obtain the dynamic stress component.

Fig. 6. (Color online) Upper chord's normal stress for each span. (a) 1st, (b) 2nd, (c) 3rd, (d) 4th, (e) 5th, (f) 6th, (g) 7th, (h) 8th, (i) 9th, (j) 10th, (k) 11th, (l) 12th, and (m) 13th spans.

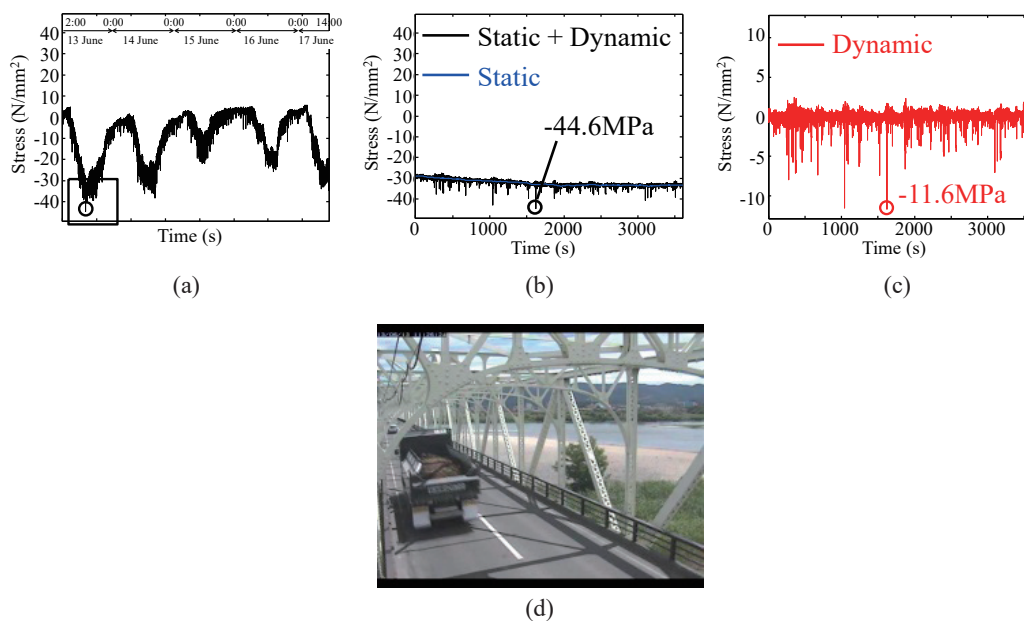
Table 1 shows each component of the minimum normal stress for each span during the monitoring period. As shown in Table 1, the 6th span is the span that presented the minimum normal stress, which is  $-44.6$  MPa. An analysis of the data corresponding to this stress and vehicle identification using the web camera are shown in Fig. 7. From Fig. 7(c), it is determined that the dynamic stress component when the normal stress reached its minimum is  $-11.6$  MPa.

Fig. 7. (Color online) Minimum normal stress during monitoring period (upper chord in 6th span). (a) Whole figure. (b) Static component in square. (c) Dynamic component in square. (d) Identified vehicle.

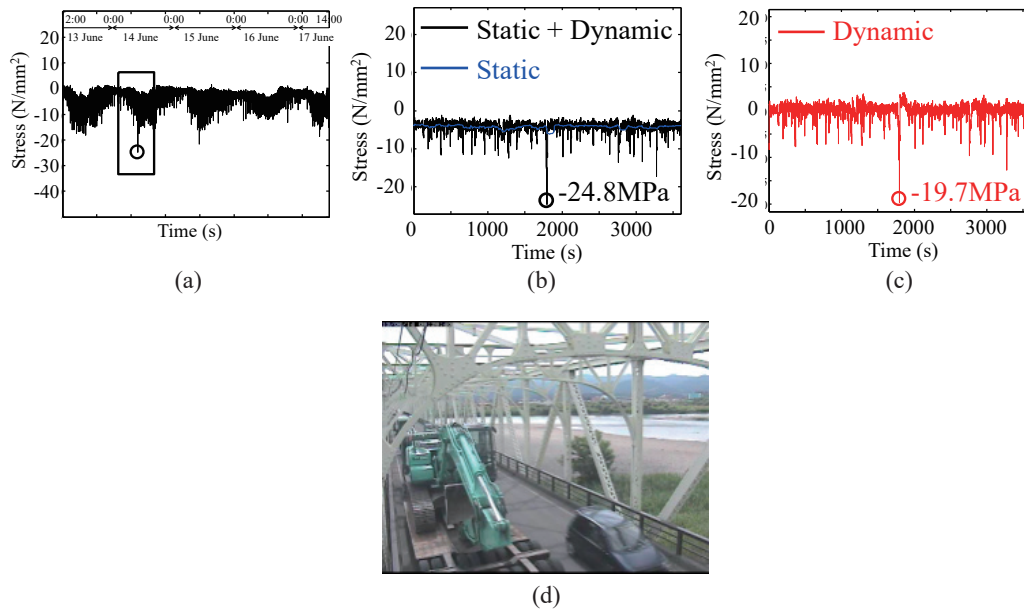
As shown in Table 1, the dynamic stress component on the 4th span is  $-19.7$  MPa. An analysis of the data corresponding to this stress and vehicle identification using the web camera are shown in Fig. 8.

Fig. 8. (Color online) Minimum dynamic normal stress during monitoring period (upper chord in 4th span). (a) Whole figure. (b) Static component in square. (c) Dynamic component in square. (d) Identified vehicle.

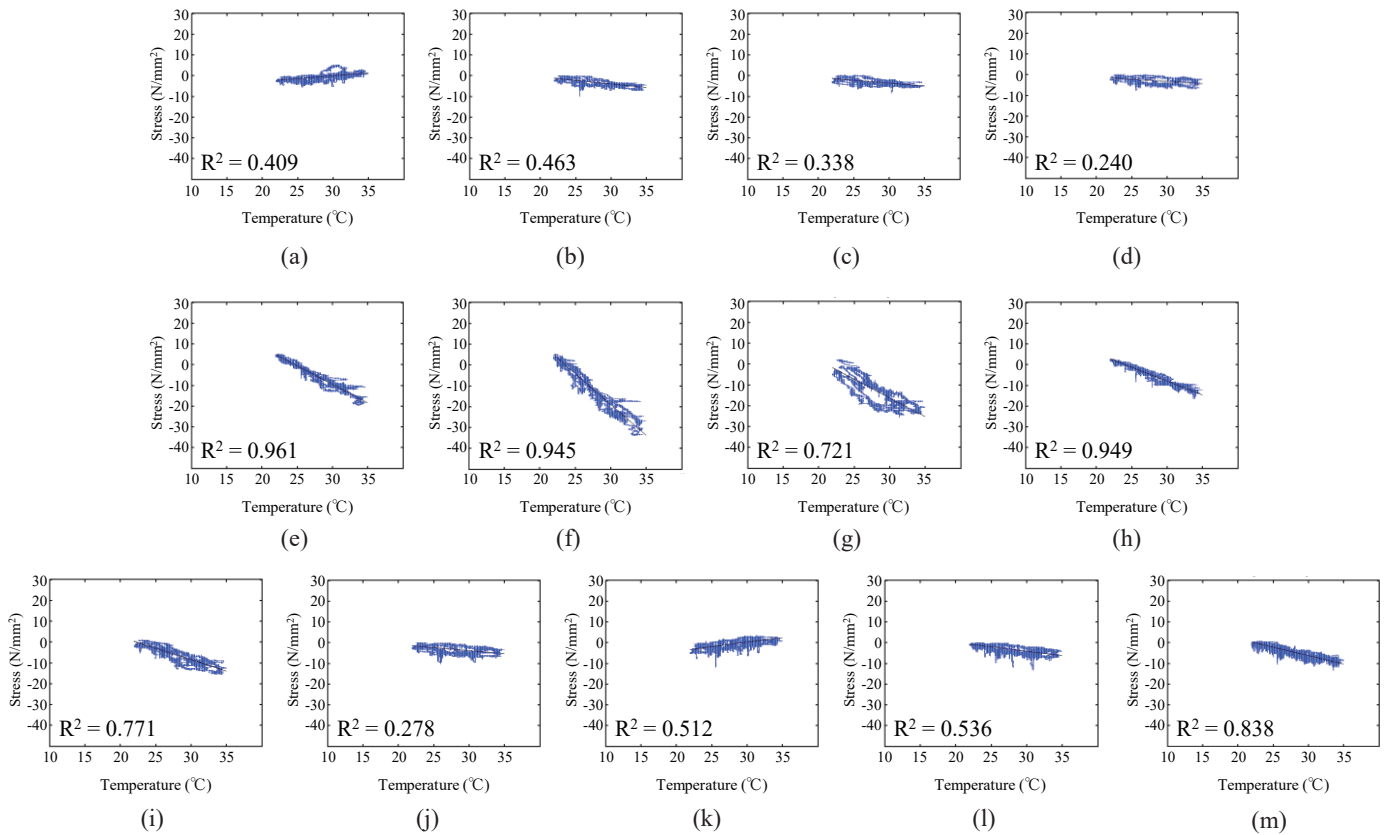
Then, from Table 1, it is found that the dynamic stress component on the 6th span is  $-33.7$  MPa. Now, using the temperature variation during the period of monitoring ( $34.9 - 21.9 = 13.0$  °C), the steel coefficient of linear expansion ( $12 \times 10^{-6}/\text{deg}$ ), and Young's coefficient of steel (200 GPa), the temperature stress is calculated. Its value is  $-31.2$  MPa. Because this stress is of the same magnitude as that of the static stress component presented in the 6th span, it is inferred that the Gerber hinge movable part is not working, and that it is fixed. Considering this, the relationship between temperature and the static stress component is shown in Fig. 9. In 5th, 6th, and 8th spans, the coefficient of determination  $R^2$  of 0.9 is exceeded. Among these 3 spans, the 6th and 8th spans are cantilever spans, and a high correlation between temperature and the static stress component corresponding to the upper chord of both spans is found. Therefore, it is considered that the Gerber hinges of these spans should be repaired preferentially.

Fig. 9. (Color online) Relationship between temperature and the static stress component. (a) 1st, (b) 2nd, (c) 3rd, (d) 4th, (e) 5th, (f) 6th, (g) 7th, (h) 8th, (i) 9th, (j) 10th, (k) 11th, (l) 12th, and (m) 13th spans.

Results after 4.5 d of monitoring showed that, in the case of the upper chord's normal stress, the static stress component fluctuation is larger than the dynamic stress component fluctuation. The minimum static stress component was found to be of the same magnitude as that of the temperature stress. Therefore, it was inferred that the Gerber hinge movable part was not working, and that it was fixed. Additionally, on the basis of the relationship between each span temperature and the static stress component, a high correlation between temperature and the static stress component corresponding to the upper chord of the 6th and 8th spans was found. It is considered that the Gerber hinges of these spans should be repaired preferentially.
