## Discussion on the Material Factors for Falling of Face Tile

**Keywords:** cement mortar, face tile construction materials, cement mortar ratio, pullout intensity, temperature variation, polymer resin, falling off

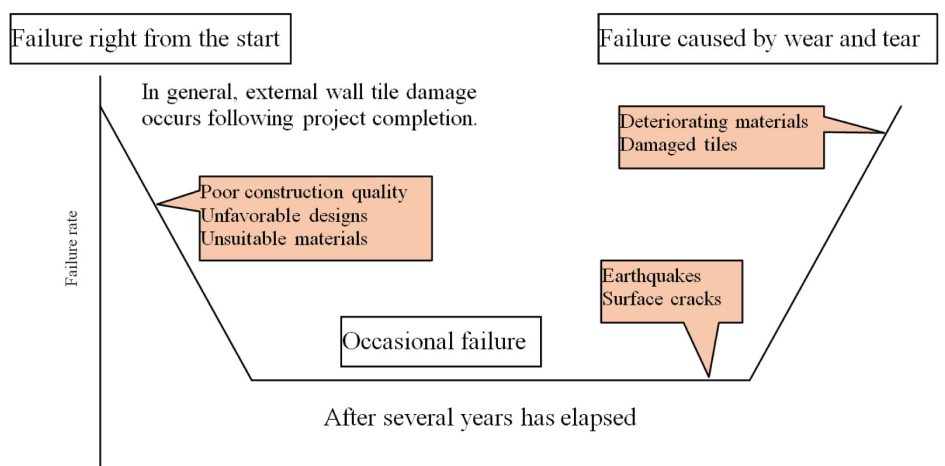
Fig. 1. (Color online) Bathtub curve.

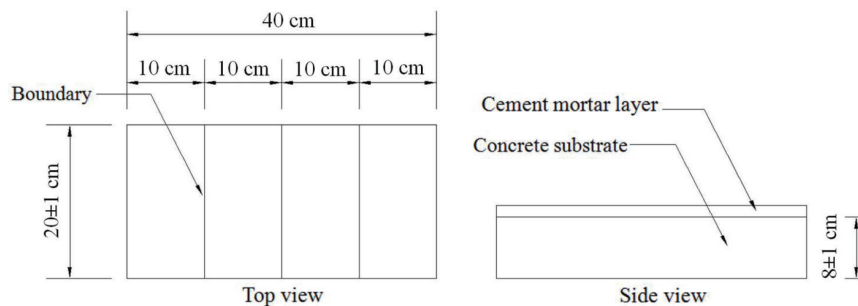
The arrangement of the test specimens used in the cement mortar pullout tests is shown in Fig. 3 and a schematic diagram of the pullout test is shown in Fig. 4.

Fig. 3. Setup of the test specimens.

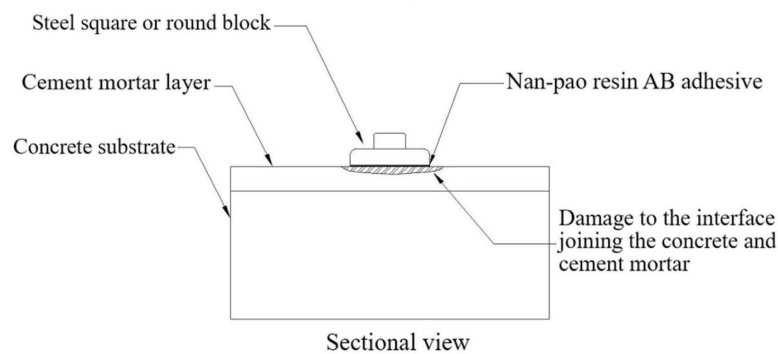
Fig. 4. Pullout test schematic diagram.

In this study, pullout test specimens (i.e., 16 total test specimens divided into four groups) were cemented with square and round steel plates, and maintained for approximately 1 h before pullout tests were conducted. At the start of the experiments, the pullout testers were affixed over the square or round blocks (Fig. 5) and manual rotational tests were performed. When the square and round steel plates peeled off from the test specimen surfaces, the pullout strengths were recorded.

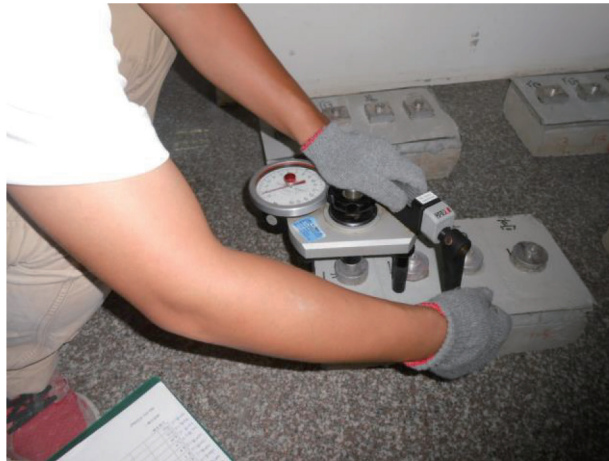
Fig. 5. (Color online) Tile pullout experiment.

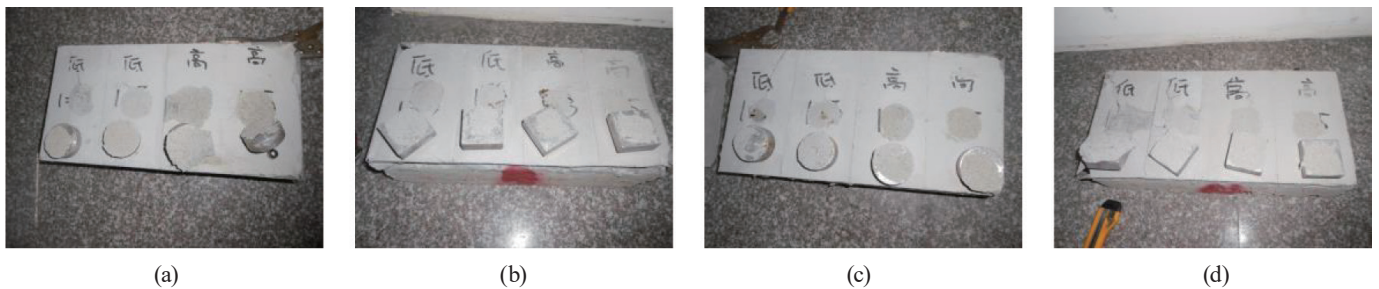
A total of 16 test specimens were used, and relevant information regarding ratios and sand content was written on the surfaces of the test specimens. The square and round steel plates peeled off from the test specimen surfaces (Fig. 6); in the uncracked cement mortar samples, the steel plates peeled off the mortar layer surfaces first when pullouts were performed.

Fig. 6. (Color online) Damage to the test specimens during pullout tests. (a) Test specimen 1, (b) test specimen 2, (c) test specimen 3, and (d) test specimen 4.
