# Development and Field Application of Fracture Detection Technology for Internal Tendons in Prestressed Concrete Bridges Using Acoustic Emission Techniques

**Keywords:** acoustic emission, prestressed concrete bridge, grout void, internal tendon, wire break, structural health monitoring

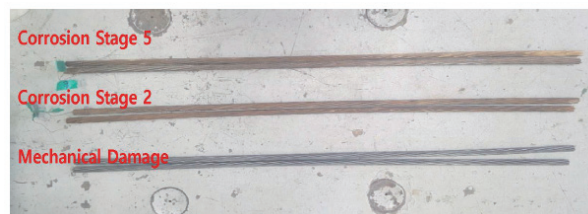
Fig. 1. (Color online) Corrosion and mechanical damage specimens.

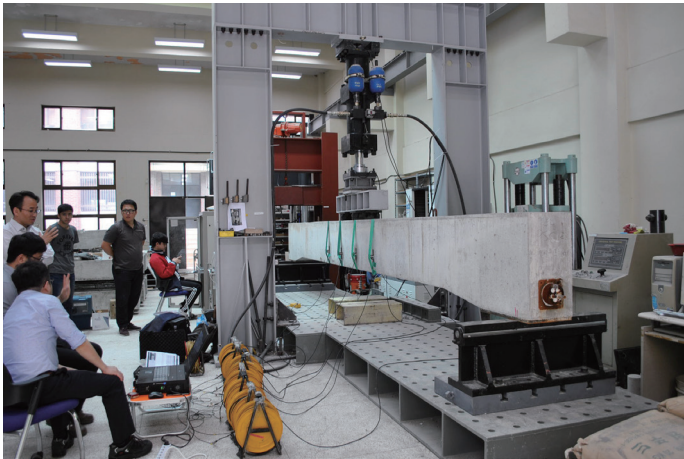
Fig. 3. (Color online) PSC structure defect detection experiment.

The experiment shown in Fig. 3 was conducted using a PSC specimen containing two prestressed strands (Fig. 4). One strand was completely severed, whereas the other had two wires subjected to intentional mechanical damage. A three-point bending test was performed to differentiate between the acoustic signals of concrete cracking and strand fracture.

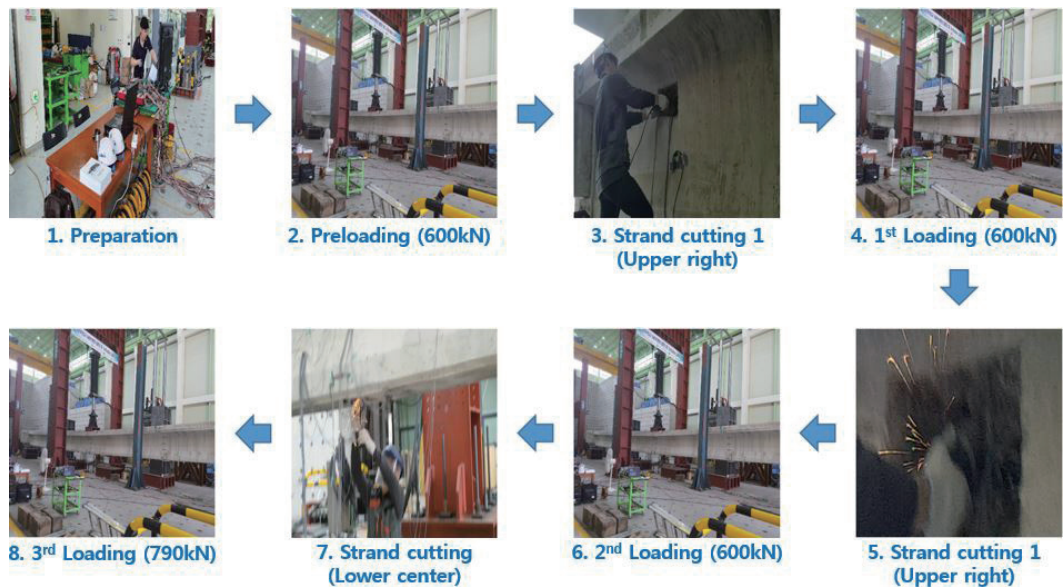
Fig. 8. (Color online) Test procedure for internal tendon destructive of I-type PSC structure.

The load application experiment followed the sequence shown in Fig. 8, with cyclic loading applied as illustrated in Fig. 9. A preloading process was conducted to ensure that the concrete was sufficiently stressed while still supported by the tendons. This process induced surface

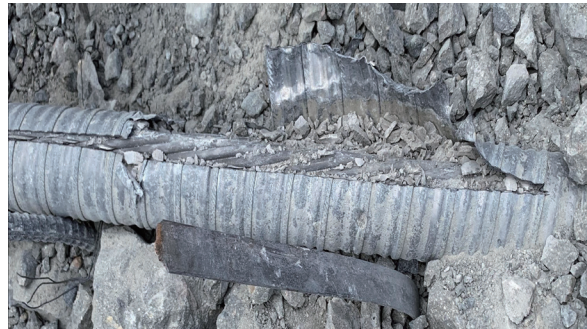
Fig. 16. (Color online) Specimen inner tendon after load test.

After the experiment, the PSC specimen was dismantled to inspect the internal tendon condition. The void location identified through measurements was near ch.2, as shown in Fig. 15. Upon inspection, it was confirmed that strands inside the tendon were in direct contact with the sheath pipe, as can be seen in Fig. 16, without being fully covered by grout. As illustrated in Fig. 17, at the bending sections of the tendon, the strands experience downward force due to prestressing, reducing the gap between the sheath pipe and the strands. Consequently, the amount of grout filling this gap naturally decreases. The actual inspection revealed that the sheath pipe and strands were in direct contact, with the missing grout forming voids.

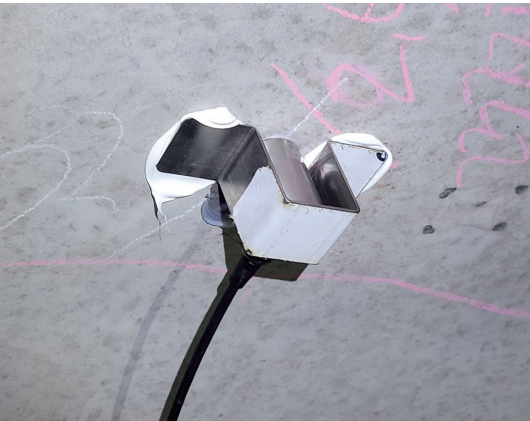
Fig. 23. (Color online) On-site installation of AE sensors.
