# Performance of a Fibre-Optic Sensor for Monitoring Cracks of Concrete, Masonry and Bituminous Elements

**Key words:** fibre-optic sensor, crack sensor, crack monitoring, OTDR

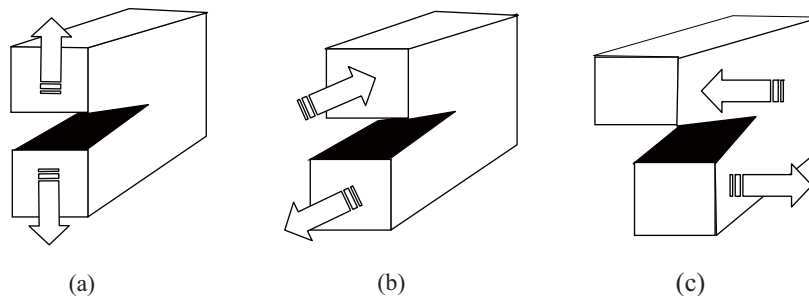
Fig. 1. Cracking modes and loading conditions in an element: (a) opening mode, (b) shearing mode and (c) tearing mode.

A crack in a structural element can be subjected to three different loading conditions (modes), as illustrated in Fig. 1. The opening mode involves loading that produces a

displacement of the crack surfaces perpendicular to the plane of the crack. The shearing mode of loading is due to in-plane shear loads, which cause the two crack surfaces to slide on one another. For this case, the displacement of the crack surfaces is in the crack plane and perpendicular to the leading edge of the crack. The tearing mode of loading is due to out-of-plane shear loading. The displacement of the crack surfaces is in the crack plane but parallel to the leading edge of the crack.

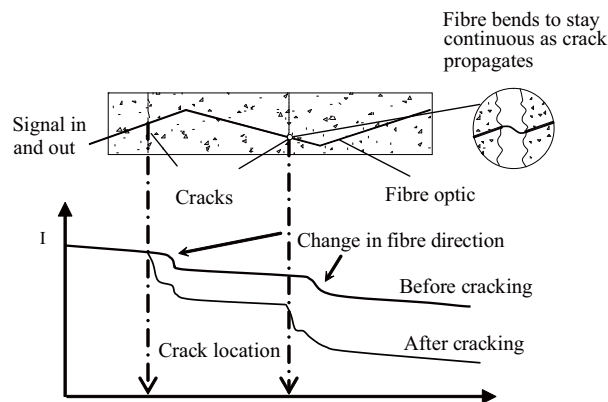
Fig. 2. Principle of operation of the sensor.

The plate sensor is a polymeric plate with an embedded optical fibre in a zigzag shape that acts as a crack transducer (Fig. 2). The optical fibre is not bonded to the polymeric plate and is free to slide. The principle is that once a crack forms in a structural element, the bonded polymeric plate will crack at the same location and in the same direction as the crack. Before the formation of cracks, the backscattered signal along the fibre should follow a relatively smooth curve (the small loss is due to absorption and scattering). When the zigzag fibre intersects the crack at an angle other than 90°, it must bend to stay

continuous.<sup>(9)</sup> This perturbation in the fibre is very abrupt, and thus can be considered as microbending. This microbending results in a sharp drop in the optical signal. This power loss can be detected and located using an OTDR, by sending a short pulse into the fibre and monitoring the backscattered signal over time. The location of the crack can be calculated from the time corresponding to the power drop. The crack opening width can also be obtained from the magnitude of the power drop if it has been calibrated.

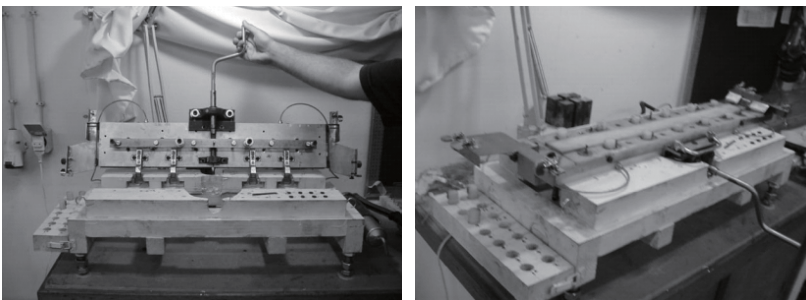
Fig. 3. Mould used to fabricate the plates.

The plates are fabricated using the mould illustrated in Fig. 3. To allow the smooth sliding of the optical fibre inside the plate when the crack is opening, a 256- $\mu\text{m}$ -diameter steel wire covered with a releasing agent is placed in the mould at the desired position. Then the polymeric material is cast into the mould. Once the material is fully cured, the plate is removed from the mould. The steel wire is subsequently pulled out from the plate and the optical fibre is inserted into the groove left by the wire.

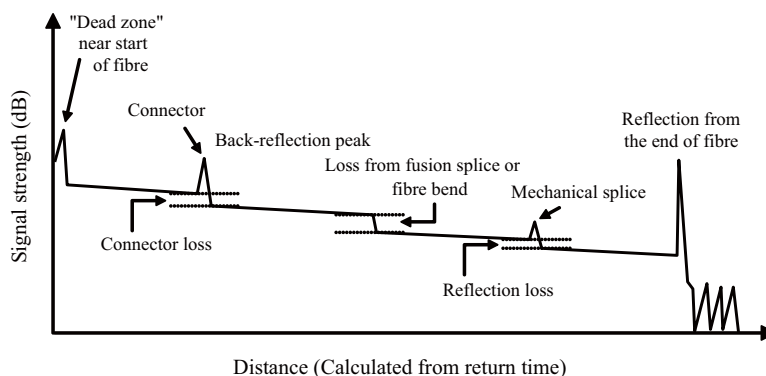
Fig. 4. Features of an OTDR plot (not to scale).

The distance scale at the abscissa is calculated from the time taken by light to reach a certain point and return. Although the optical pulse is very short and the receiver responds very quickly, the signal received from the part of the fibre closest to the instrument is not useful. This “dead zone” ranges from a few metres to about 20 m. The largest peak in Fig. 4 is the reflection at the end of the fibre. The next largest peak is the reflection from a connector. It is possible to see that the signal after the connector is slightly lower than it was before the connector; this drop is due to absorption and scattering at the connector. Mechanical splices also reflect some light back to the instrument and cause a measurable loss, but both loss and reflection are smaller in this case. The plot also shows the effect of a fusion splice, which causes a small loss but does not reflect light back to the OTDR. For a good fusion splice, the loss can be nearly undetectable.

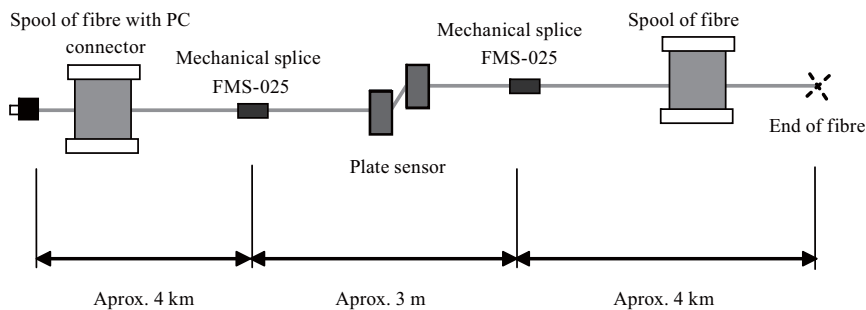
Fig. 5. Proposed wiring configuration.

The calibration process using an OTDR is much more time- and resource-consuming than that using a power meter. However, the calibration curves obtained from this process can help us estimate the behaviour of the sensor in real applications in which data acquisition is performed using the miniature OTDR with the wiring configuration shown in Fig. 5.

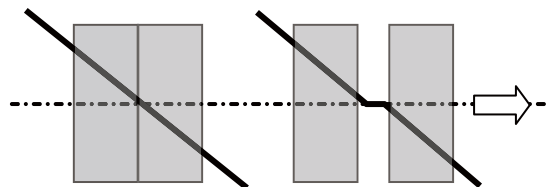
Fig. 6. Specimen used in the calibration tests.

Several calibrations were performed in this study to determine and predict the behaviour of the sensor under different operating conditions. Figure 6 shows the specimens used in the calibration tests. The specimen dimensions are representative of the parameters determining the sensor, i.e., the length of the fibre in the calibration specimen is similar to the length between the inflection points of the zigzag fibre inside the sensor plate. Before the polymer is cast to fabricate the specimen, an inclined steel

wire is placed inside the mould. After the polymer hardens, the steel wire is extracted and the specimen is cut into two halves using a diamond saw to simulate the existence of a linear crack. Then, the optical fibre is manually inserted in the hole formed by the extraction of the steel wire.

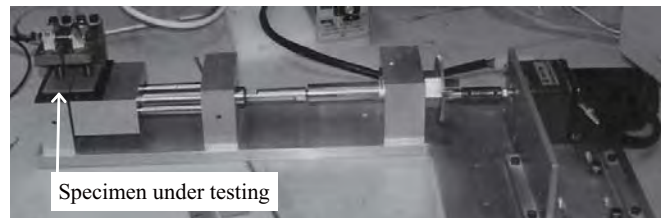
Fig. 7. Photograph of the mechanical crack simulator described by Leung *et al.*<sup>(9)</sup>

The calibration tests were carried out using the mechanical crack simulator described by Leung *et al.*<sup>(9)</sup> This simulator, illustrated in Figs. 7 and 8, was designed so that the crack opening width could be measured using a linear variable differential transformer (LVDT). The testing device comprises a fixed block and a movable block. The moving part rests on two hardened steel rods and has four precision ball bearings to keep it aligned and moving with very little friction. The specimen is clamped onto the blocks using tightened screws (Fig. 7). Using a motor and a connecting rod, the movable block is pulled away from the fixed block to simulate crack opening.<sup>(13)</sup>

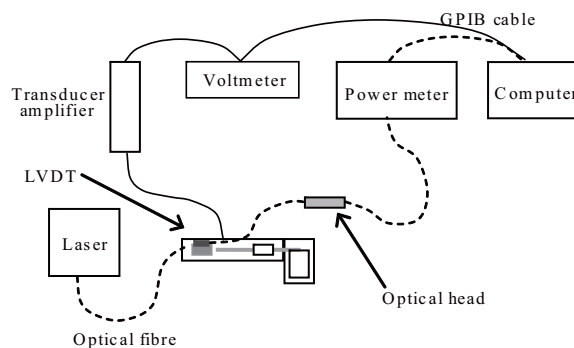
Fig. 8. Experimental setup for calibration tests.

The procedure to calibrate the corresponding intensity loss versus the crack opening width began with the installation of the optical fibre in the hole of each specimen. Then each half of the specimen was sequentially clamped. The recording of the displacement and optical power loss started when the motor was turned on to displace the movable

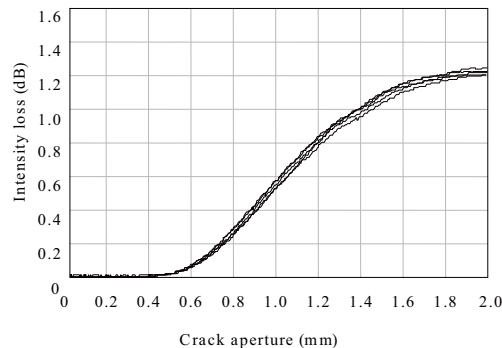
Fig. 9. Calibration of a 15° sensor made with Pol. 2a1 polyester.

Figures 9 and 10 show the relationship between optical power loss (in dB) and crack opening width (in mm) obtained in the calibration tests carried out using two different versions of the plate sensor with the fibre at 15 and 30° to the crack normal, respectively.

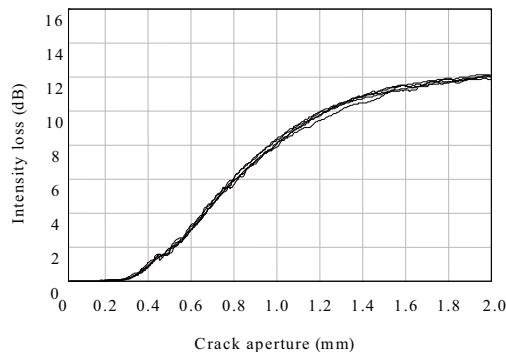
Fig. 10. Calibration of a 30° sensor made with Pol. 2a1 polyester.

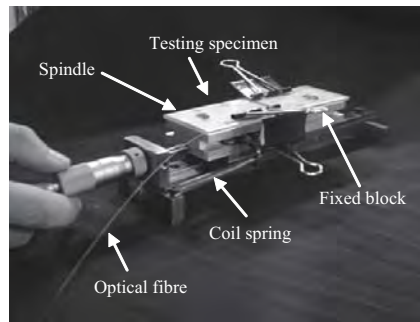
Fig. 11. Photograph of the manual crack simulator.

Figure 11 shows the manual crack simulator used to simulate the crack opening and to perform the calibrations using the miniature OTDR. The device is made of a bench micrometer assembled with two blocks of aluminium resting on two movable parts coupled to a hardened steel base. The base is designed to keep the movable parts and the ball bearings inside them aligned without rotation, and moving with very little friction.

After the two sides of the specimen were clamped to the aluminium blocks, the movable part below one of the blocks was fixed by tightening a screw at its bottom. By turning the spindle of the micrometer, the other block was moved to separate the fixed and movable blocks to simulate crack opening. Measurements were performed at 0.1 mm intervals since the accuracy of the micrometer was 0.005 mm.

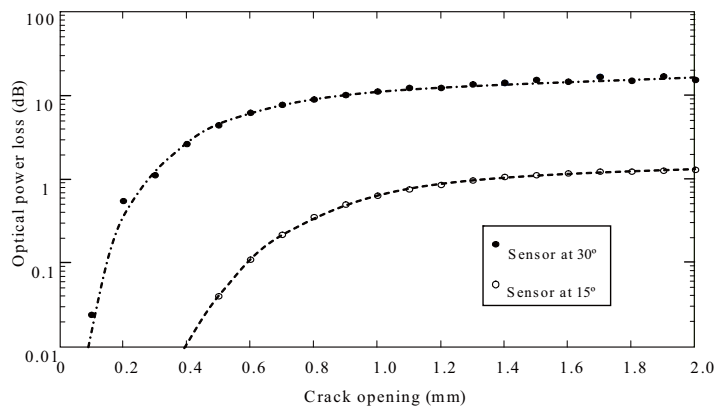
Fig. 12. Calibration of 15 and 30° sensors made with Pol. 2a1 polyester with the addition of A1200 abrasive.

Because of the low spatial resolution of the miniature OTDR, each point in the output of the OTDR represents the integrated loss over several metres or several tens of metres of fibre depending on the optical pulse width. After some preliminary tests, it was found that an optical pulse width of 100 ns and a fibre length of 3 m between the mechanical splices (that connect the sensor to the two fibre cylinders shown in Fig. 5) provided the most consistent results. Figure 12 shows the relationship between optical

power loss (in dB) and crack opening width (in mm) obtained in the calibration tests carried out with two different versions of the plate sensor, with the fibre at 15 and 30° to the crack normal, respectively. The results from the OTDR measurements are shown as dots since they are taken at discrete crack opening widths. The averaged results from the direct power measurement are shown as the dotted curve. For the 15° sensor, very good agreement can be observed between the direct power and OTDR measurements. For the 30° sensor, the OTDR measurements tend to show a higher loss for the same crack opening, but the trends of the two measurements are very similar. Generally speaking, the agreement can be considered to be satisfactory.

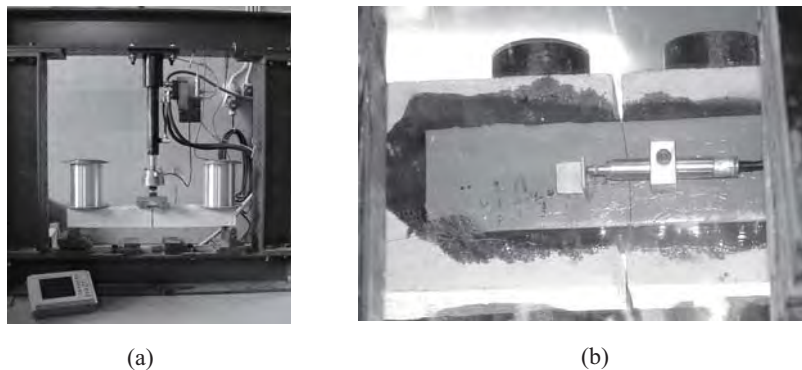
Fig. 13. Plate sensor externally attached to an SFRC beam: (a) front view and (b) plate sensor.

The first evaluation of the surface-attached plate sensor involved the flexural testing of two steel-fibre-reinforced concrete (SFRC) beams with a cross section of  $10 \times 10 \text{ cm}^2$  and a span of 80 cm. The bearing supports were separated by 75 cm, while the two points of loading application were separated by 10 cm. A plate sensor was attached to the bottom of the beam. In the centre of each beam, notches of 5 mm (width)  $\times$  20 mm (depth) were cut at both lateral faces. The purpose of notching the beams was to define the initial location of cracking, so that crack opening could be simultaneously monitored using an LVDT attached to the sensor plate at the location of the potential crack (Fig. 13).

- In the calibration tests two separate blocks were employed so that the simulated crack was perfectly straight. On the other hand, the crack formed in the plate sensor on the SFRC beam is clearly not straight (Fig. 13(b)). This will have an effect on the bending of the fibre. According to the results of numerical simulations, the effect is more significant for the small-angle sensor.

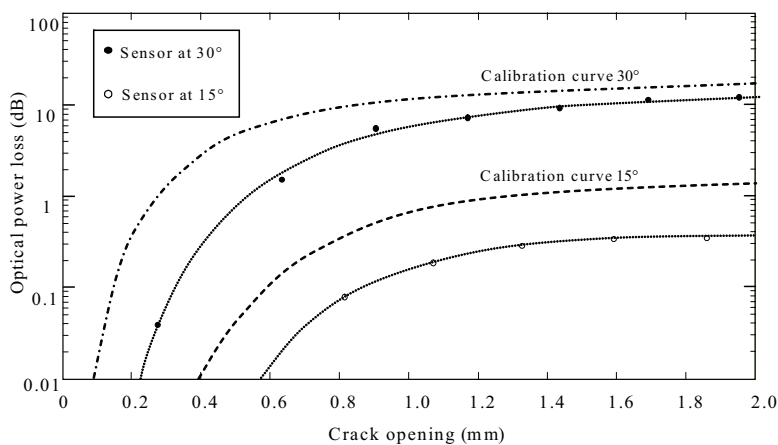
Fig. 14. Experimental results for SFRC beams.

Figure 14 shows the relationship between optical power loss and crack opening width. The calibration curves presented in §5.2 are also shown. The concordance between the results obtained in the laboratory and in the calibration tests is extremely high if we consider the following aspects:

- After cracking occurs in the structural element, there is an inevitable delay in the response of the plate sensor. This is because the polymeric material used to fabricate the sensor is more ductile than the concrete used for making the beams, even when brittle particles are incorporated in the polymer. This explains why the displacement measured using the LVDT is greater than the value predicted using the sensor (Fig. 14).

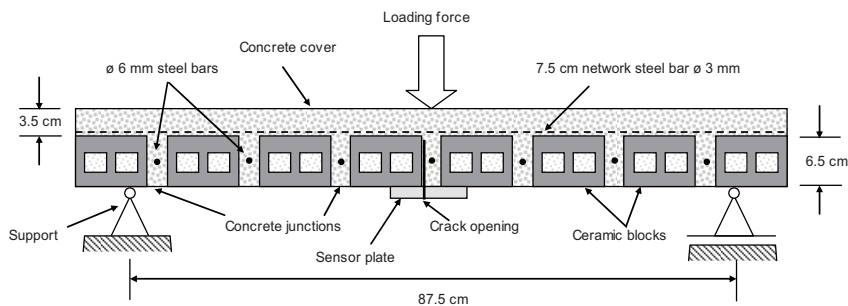
Fig. 15. Configuration of the reinforced masonry slab.

In this study, a prefabricated reinforced masonry slab was used. Details of the procedure for building the slab and the mechanical properties of the materials can be found in Ref. 15. The cross-section dimensions are  $9.5 \times 45.5 \text{ cm}^2$  and the span is 87.5 cm. Figure 15 shows the configuration of the slab with the specimen dimensions, loading position and plate sensor location.

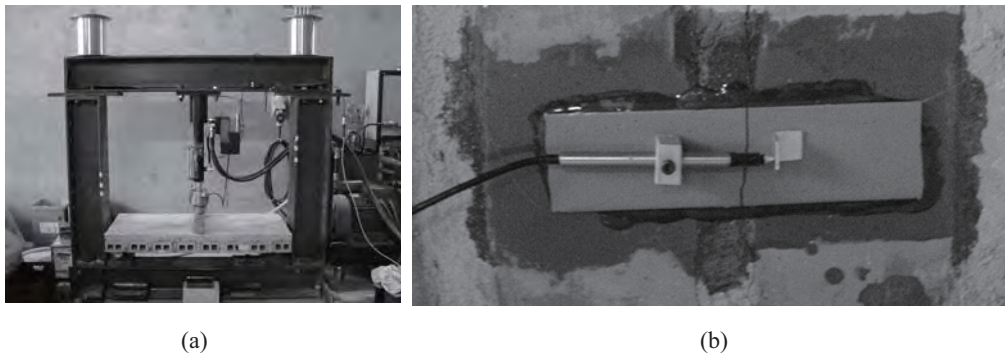
Fig. 16. Plate sensor externally attached to a masonry slab: (a) front view and (b) plate sensor.

The slab was tested under a three-point-bending condition (Fig. 16(a)). A notch was cut in the bottom face at the centre of the span to define the initial location of cracking. The specimen was loaded under a controlled velocity of 0.005 mm/s. The slab was subjected to 9 levels of sustained loading, each with a 0.4 mm increment in

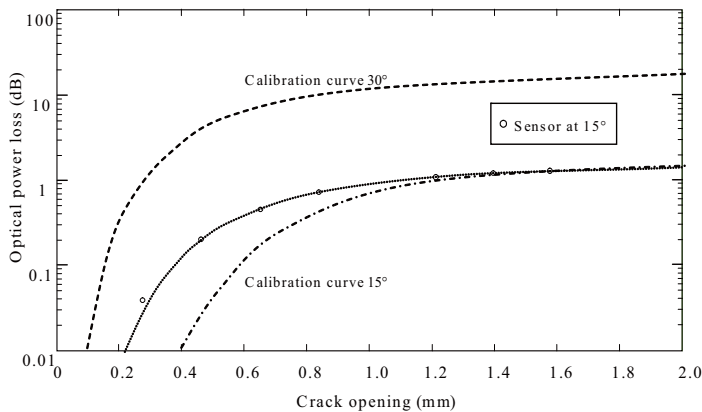
Fig. 17. Experimental results for the masonry slab.

Figure 17 shows the relationship between optical power loss and crack opening for different tests. The calibration curves obtained in §5.2 are also shown. The concordance between the results obtained in this application and in the calibration test is excellent. In this case the optical intensity loss is higher than the calibration results for the  $15^\circ$  sensor. As can be observed in Fig. 16(b), the angle between the crack normal and the fibre is close to  $20^\circ$ , indicating possible load misalignment resulting in an increased loss.

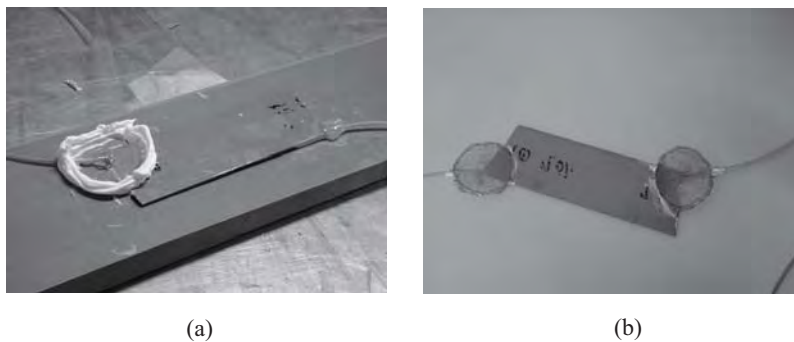
Fig. 18. Preparation of an embeddable plate sensor: (a) sealing of joint to protect the optical fibre and (b) plate sensor to be embedded.

Figure 18 shows the preparation of a  $15^\circ$  plate sensor to be embedded in concrete or bituminous elements. To protect the part of the fibre outside the sensor plate from breakage, two thin plastic pipes of 1 m length were used on each side. Grease was

applied to allow free sliding of the optical fibre inside the pipes, so that when the crack opens, the fibre can move into the space between the opposing crack surfaces without resistance. The location of the joint between the plastic pipes and the sensor was sealed using a small quantity of pure polyester. Finally, to prevent damage during transportation and installation, the exposed ends of the optical fibre were protected using plastic bags.

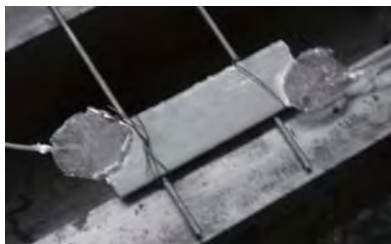
Fig. 19. Plate sensor embedded in an SFRC beam: (a) fixing of the plate sensor, (b) installation of the plate sensor and (c) crack opening at the level of the plate sensor.

Figure 19 shows the installation of the embedded plate sensor and the experimental test performed to detect and measure the crack opening. The plate sensor was fixed to a couple of steel rebars (Fig. 19(a)) and placed inside the mould at a distance of 3 cm from the bottom of the mould (Fig. 19(b)). The steel rebars made it possible for the plate sensor to remain perfectly vertical during and after the vibration of the concrete. The LVDT attachment was designed to monitor the opening of the crack at the level of the optical-fibre sensor. The loading increment was controlled so that the crack opened in steps of 0.2 mm (as measured using an LVDT at the level of the sensor plate). After each step the loading was maintained for 30 s to perform the data acquisition using the OTDR.

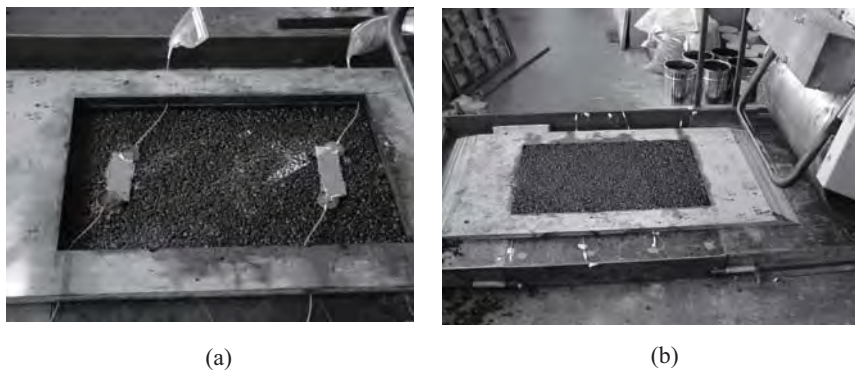
Fig. 20. Fabrication of the asphalt slab with the plate sensor installed between the two layers: (a) installation of plate sensors on the bottom layer and (b) compaction of top layer using vibrating wheel roller.

To simulate the characteristics of an old pavement, the mechanical properties of the asphalt mixture comprising the bottom layer were artificially degraded to reduce the binder resilience by keeping the mixture inside an oven at 135°C for 24 h.<sup>(18)</sup> Figure 20 shows the procedure for the production of the asphalt slab with the plate sensor installed between the two layers.

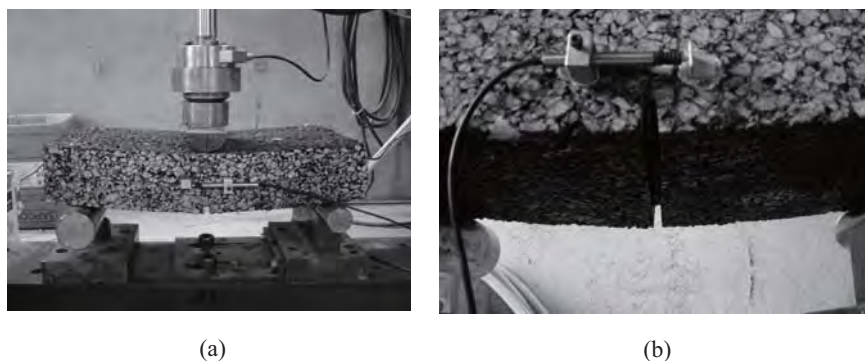
Fig. 21. Loading test on the bituminous slab: (a) general view and (b)  $5 \times 20 \text{ mm}^2$  notch cut at the bottom.

The asphalt slab obtained by this procedure was cut into two specimens with dimensions 10 × 35 × 50 cm<sup>3</sup>. These specimens were tested under a three-point-bending condition (Fig. 21(a)). The bearing supports were separated by 40 cm.

In the centre of the bottom face, a 5 × 20 mm<sup>2</sup> notch was introduced (Fig. 21(b)) to define the initial location of cracking. The LVDT attachment was designed to monitor the opening of the crack at the level of the optical-fibre sensor. The loading increment

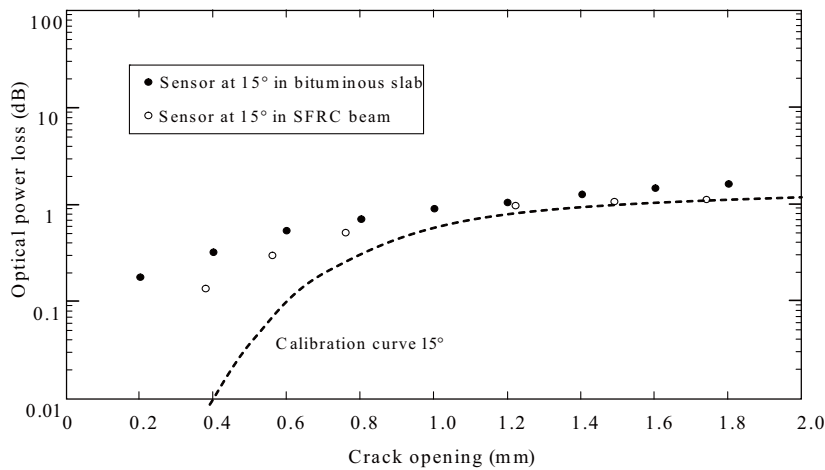
Fig. 22. Experimental results for SFRC beams and bituminous slabs.

Figure 22 shows the relationship between optical power loss and crack opening width for different tests, together with the calibration curves presented in §5.2.

The agreement between the results obtained in these tests and in the calibration test is satisfactory, particularly for higher values of crack opening width.

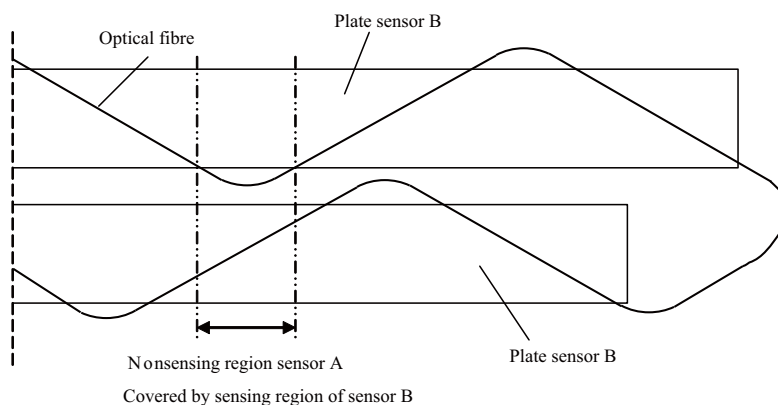
Fig. 23. Plausible arrangement for crack monitoring in practice.

In this work, only plates with a single inclined fibre are made and tested. These plates can only cover a small region of the member. Figure 23 shows two sensor plates that can be used together to cover a wide region in practical situations. On each plate, the fibre extends in different directions in different regions, and there are parts with no fibres (and hence no sensing capability). The use of two plates in parallel makes it possible to have the nonsensing part of one plate covered by the sensing part of the other plate. In this way, crack sensing can be performed over the whole region spanned by the two parallel plates.
