# Performance Evaluation of Hinges in Long-Span Cantilever Steel Truss Bridges by Structural Health Monitoring

Takeshi Miyashita,\* Eiji Iwasaki, and Masatsugu Nagai

Nagaoka University of Technology, 1603-1 Kamitomioka, Nagaoka, Niigata 940-2188, Japan

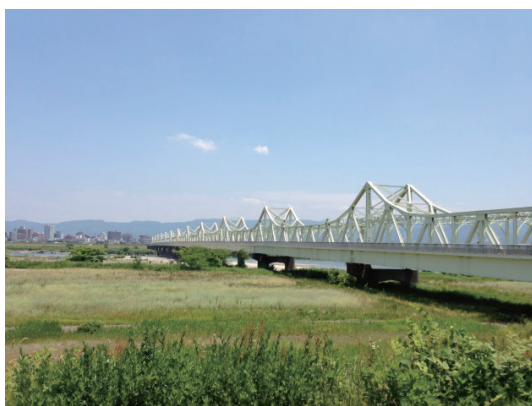
The bridge of study is Chosei Bridge, an 850.8-m-long bridge built over Shinano River, located in Niigata Prefecture. It is a 13-span (67.50 + 11@65.00 + 67.50 m) cantilever (Gerber) steel truss bridge completed and opened to traffic in 1937 (Fig. 1). The road width corresponding to this bridge is 7.50 m. The pedestrian bridge adjacent to Chosei Bridge was constructed in 1972.

Fig. 1. (Color online) Bridge of study (Chosei Bridge).

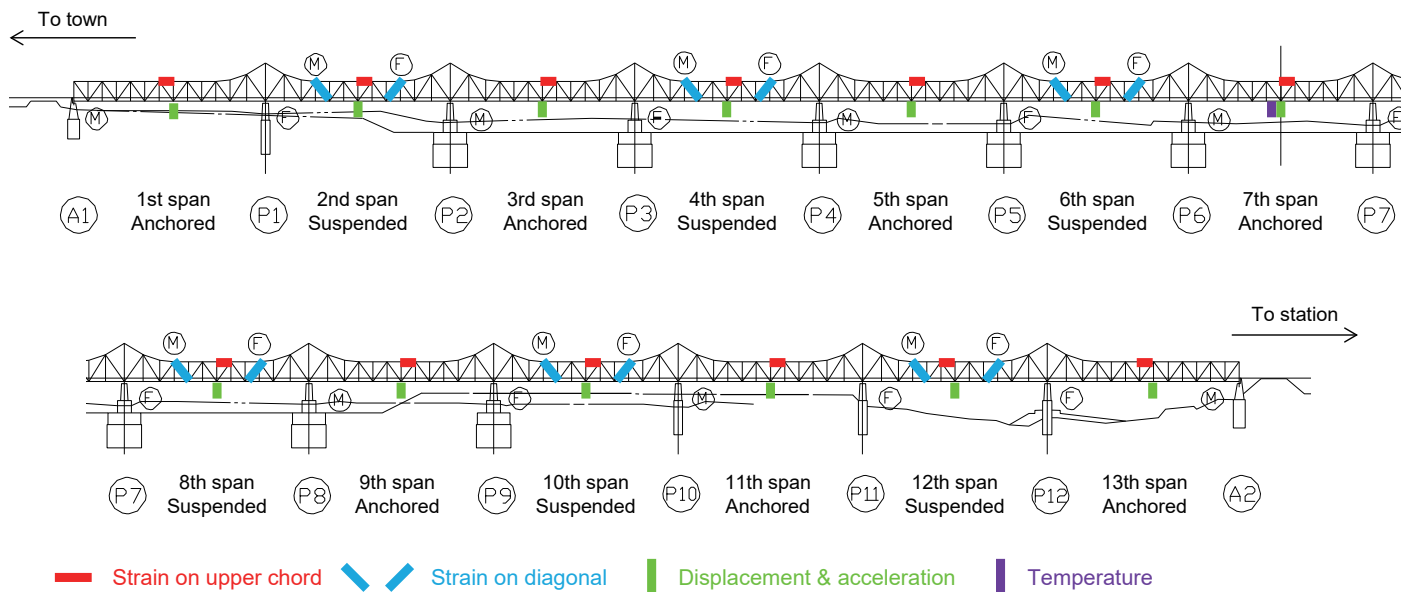
Fig. 3. (Color online) Measurement location.

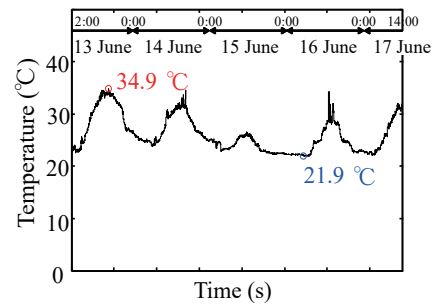
Fig. 5. (Color online) Temperature during monitoring period.

Temperature variation corresponding to the vicinity of the 7th span's center, measured with the installed thermocouple, is shown in Fig. 5. During the measurement period, the maximum temperature was 34.9 °C, and the minimum temperature was 21.9 °C. The temperature when the initial measurement was carried out, on May 22, 2013, was 21 °C.
