Pitting Corrosion on Diamond-like Carbon Films in High Concentration Sodium Hydroxide Solutions

Keywords: diamond-like carbon, corrosion, sodium hydroxide solution, silicon, pinhole

Chemical resistance to high concentrations of sodium hydroxide solutions on diamond-like carbon (DLC) films was investigated by immersion testing. DLC films were deposited on silicon (Si) and polytetrafluorethylene (PTFE) plates. These samples were put into a 17 at.% sodium hydroxide solution. The DLC films on PTFE were maintained for 48 h, although most of the DLC films deposited on Si were removed. To understand this reaction, the results of immersion tests using 10 wt.% sodium hydroxide solution were observed *in situ*. Many bubbles appeared after 14 h. The number of the bubbles, which were reaction points, increased with the duration of the immersion test. We observed areas where the DLC film remained, and these places experienced no change. DLC films were peeled away because of the corrosion of the Si substrate by the sodium hydroxide. These bubbles were probably hydrogen gas, which results from the reaction between silicon and sodium hydroxide. Hence, the DLC films contained weak points against

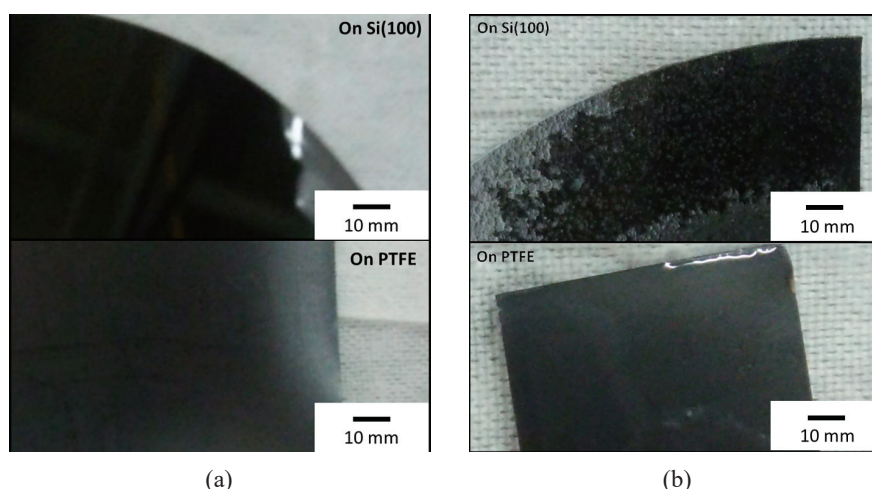
Fig. 1. (Color online) Appearance before and after 12 h of exposure: (a) initial and (b) after 12 h.

The appearance of the film surface before and after 12 h of corrosion testing in the highly concentrated solution of sodium hydroxide solution (17 wt.%) was obtained and is shown in Fig. 1. After 12 h, some pores were observed at some sites on the sample deposited on Si(100), although no changes were noted on the DLC film deposited on PTFE. After 24 h, the DLC film at most places deposited on the Si(100) substrate had disappeared, where the DLC film deposited on PTFE evidenced no change. To understand the microstructural changes, images of the film surfaces before and after testing were obtained using a microscope. Figure 2 shows photomicrographs of the sample surface of DLC films deposited on Si(100) before and after 12 and 24 h of exposure. The surface before the test was smooth and mirror-like. After 12 h of exposure, the film surface displayed many pores 50 μm in diameter. These pores appeared to be square. After 24 h, the pores had grown and the number of pores had also increased. After 48 h, no DLC films were left on Si(100). On the other hand, DLC films on PTFE showed no change after 48 h of corrosion testing, as shown in Fig. 3.

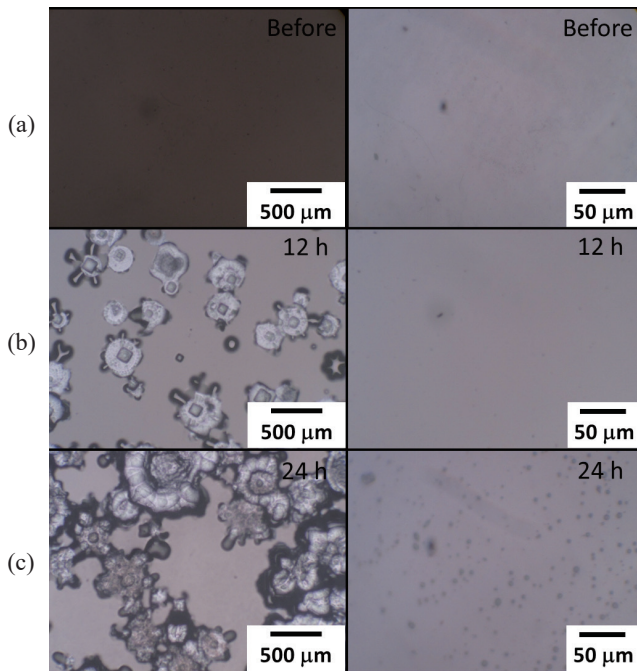
Fig. 2. (Color online) Photomicrographs of the surface of DLC films deposited on Si(100) (a) before, after (b) 12, and (c) 24 h of exposure.

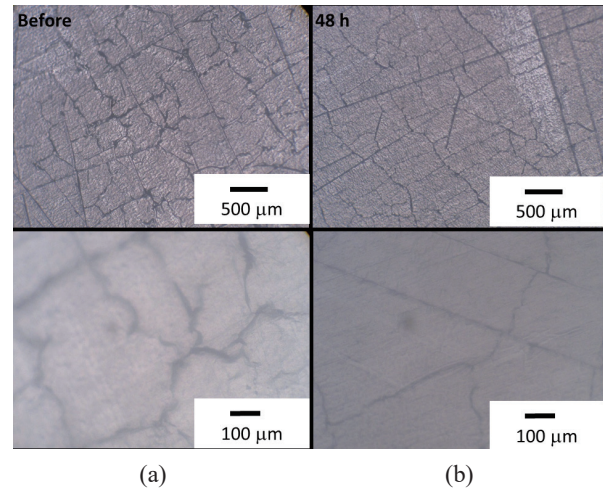
Fig. 3. (Color online) Photomicrographs of the surface of DLC films deposited on PTFE (a) before and (b) after 48 h exposure.

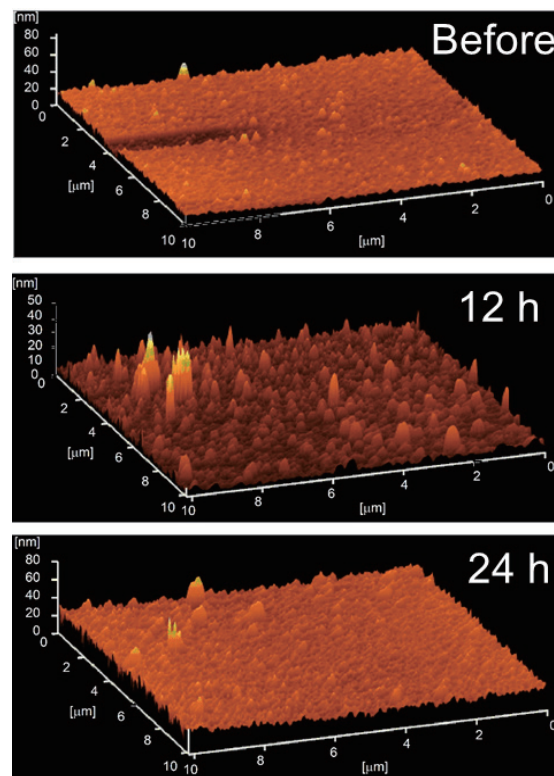
Fig. 4. (Color online) AFM images before and after corrosion tests.

To understand the microstructural changes, AFM images were taken before and after corrosion tests, as shown in Fig. 4. Areas inside the pores and near the pores were hard to observe by AFM because the roughness in these area was too high to observe with this method. Therefore, we obtained surface images at the areas where DLC remained. The ten-point average surface roughness, R_z , of the sample surface changed from 22.5 to 44.5 nm as a result of the corrosion test after 12 h. The value of R_z was 16.9 nm after 24 h. The mean of roughness value, R_a , of the sample surface was 2.0, 2.8, and 1.5 nm for before samples, and at 12 and 24 h after corrosion testing, respectively. The main reason for the destruction of DLC films was not the corrosion of DLC films, because DLC films on PTFE were maintained after 48 h of the testing. These results suggest that the pores are the result of partial pitting corrosion, and that the sodium hydroxide solution reached the Si substrate through these holes. It is likely that Si was etched by the sodium hydroxide solution⁽¹⁸⁾ and the DLC films were destroyed by the etching of the Si substrate.

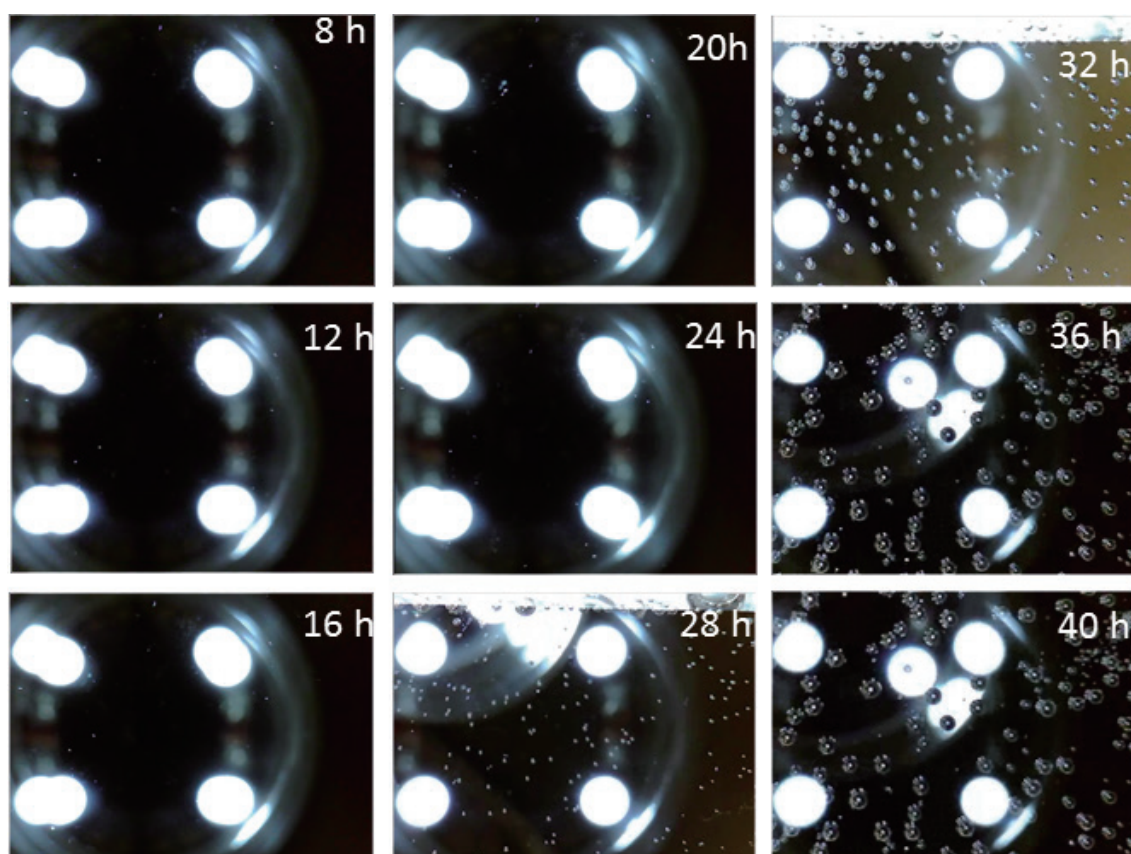
Fig. 5. (Color online) Photomicrographs obtained during *in situ* observation of corrosion of DLC films on Si(100).

Thus, the *in situ* observation of corrosion of DLC films on Si(100) was investigated. Figure 5 shows surface images of DLC films deposited on Si(100) at 4 h increments during corrosion testing. These images revealed no changes during 16 h. A few sites shows the evolution of microbubbles after 20 h, and the number of bubbles increased with time. After 28 h, the number of sites generating bubbles rapidly increased. These bubbles were also generated on the non-coated side, because the silicon was easily corroded by sodium hydroxide solution. Hence, these bubbles are caused by the reaction between the silicon substrate and the sodium hydroxide solution.
